NTSB Recommends Fire Suppression Systems on All Cargo Airplanes

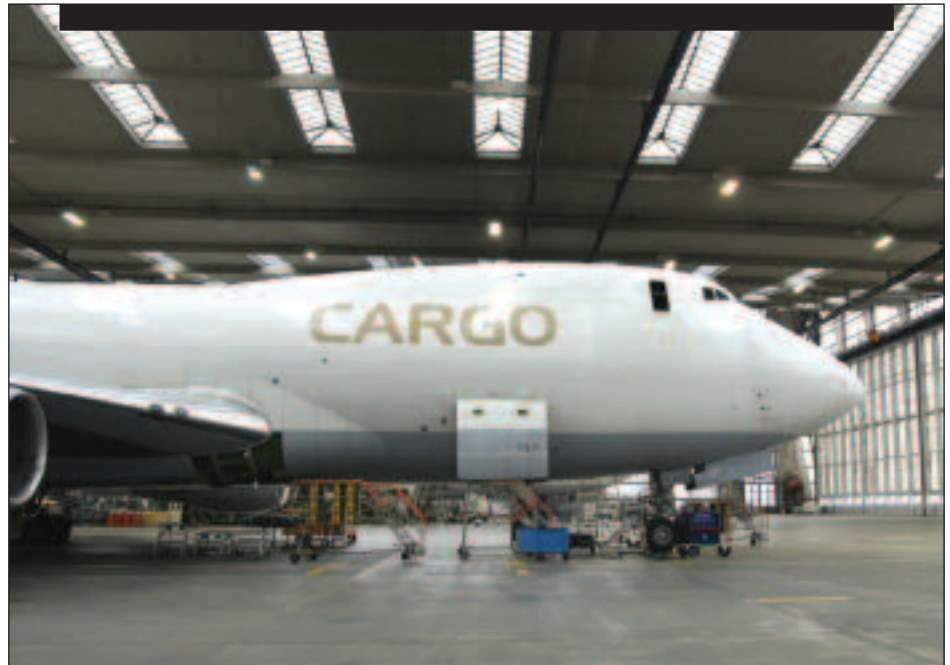
The report states that examinations of the recovered components revealed no evidence of any preexisting power plant, structural, or system failures. Also noted was that given the length of time that the fire burned and the resulting destruction of potentially helpful evidence, the post-fire condition of the cargo containers and contents and the surrounding airplane

structure provided no evidence that indicated what initiated the fire.
